LOWER HOUSATONIC RIVER BASIN
SEYMOUR, CONNECTICUT

PEAT SWAMP RESERVOIR DAM CT 00088

PHASE I INSPECTION REPORT NATIONAL DAM INSPECTION PROGRAM

AUGUST 1978

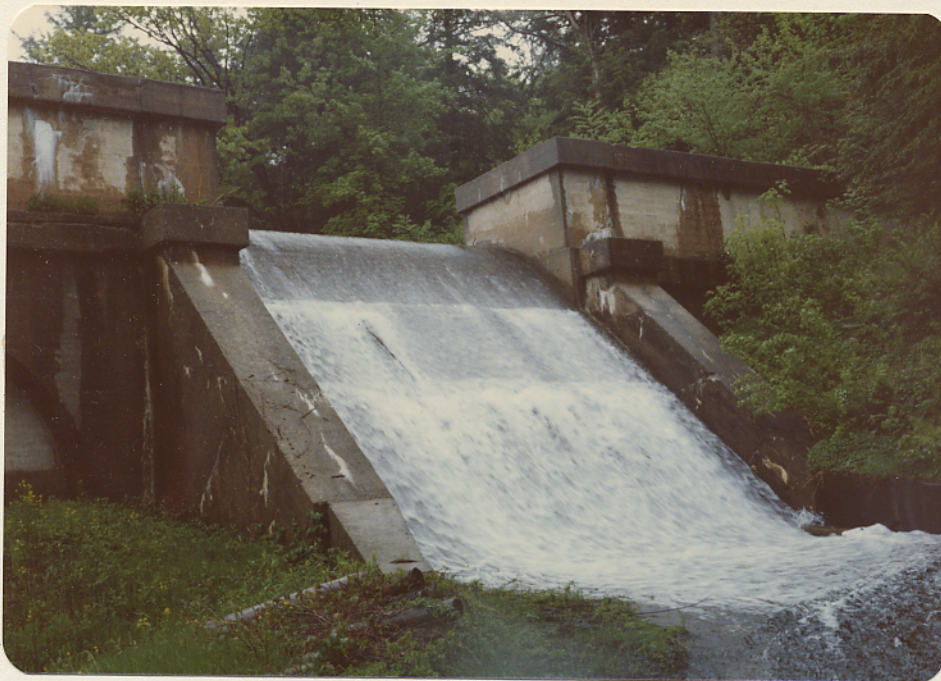
PHOTO NO.3 - View of spillway. Length of weir is 19 feet.

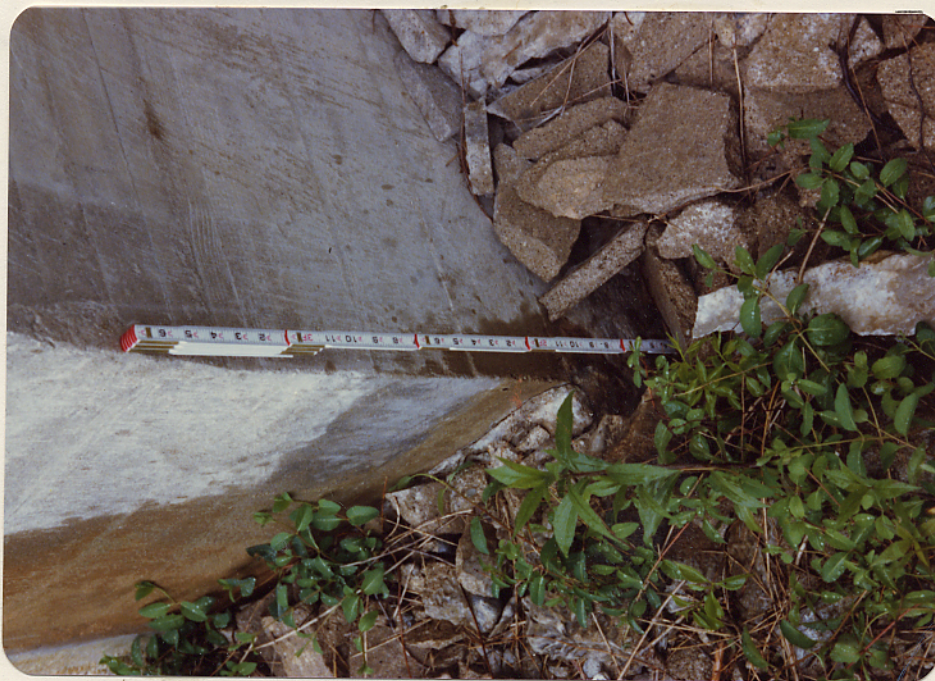
- (1) There are holes at contact of earth embankment and base of concrete dam possibly caused by seepage at the contact between top of old rubble wall and base of concrete raising.
- (2) There are indications of vertical settlement/movement at the two monoliths adjacent to and to the right of the spillway. This is indicated at the spillway wing walls where they abut the above monoliths. The relative movement varies between 1/4 and 1/2 inches.
- (3) Spillway structure shows no signs of stability problems.
- (4) Significant seepage at junction between 1916 and 1925 raisings most notable immediately to the right of the spillway.

PHOTO NO.4 - Cavity next to concrete wall adjacent to fourth buttress from spillway.

4. The embankment holes should be repaired.

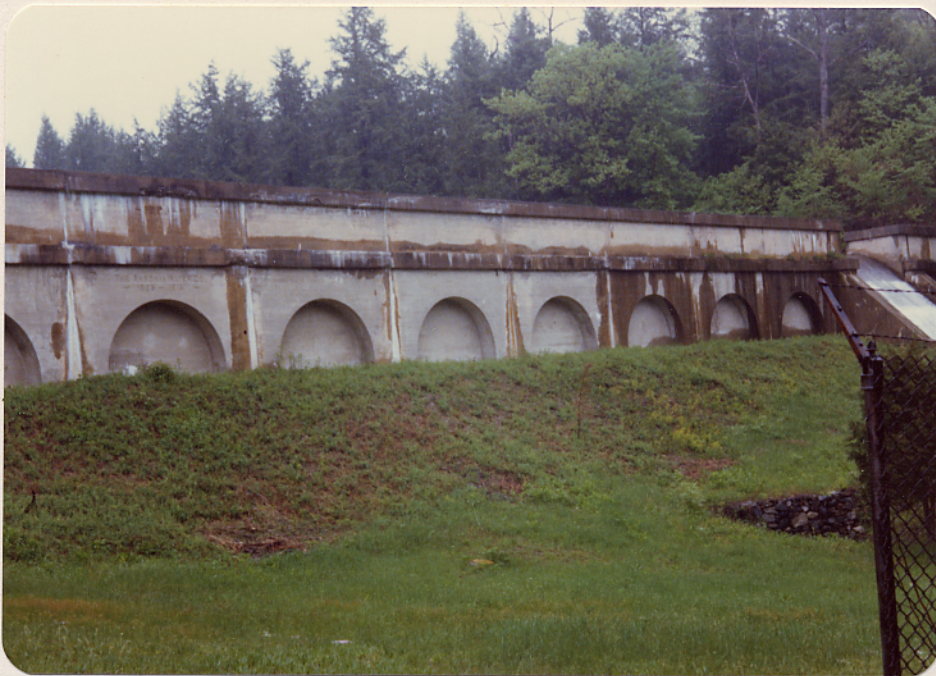
PHOTO NO.1 - General view of dam, spillway and left abutment.

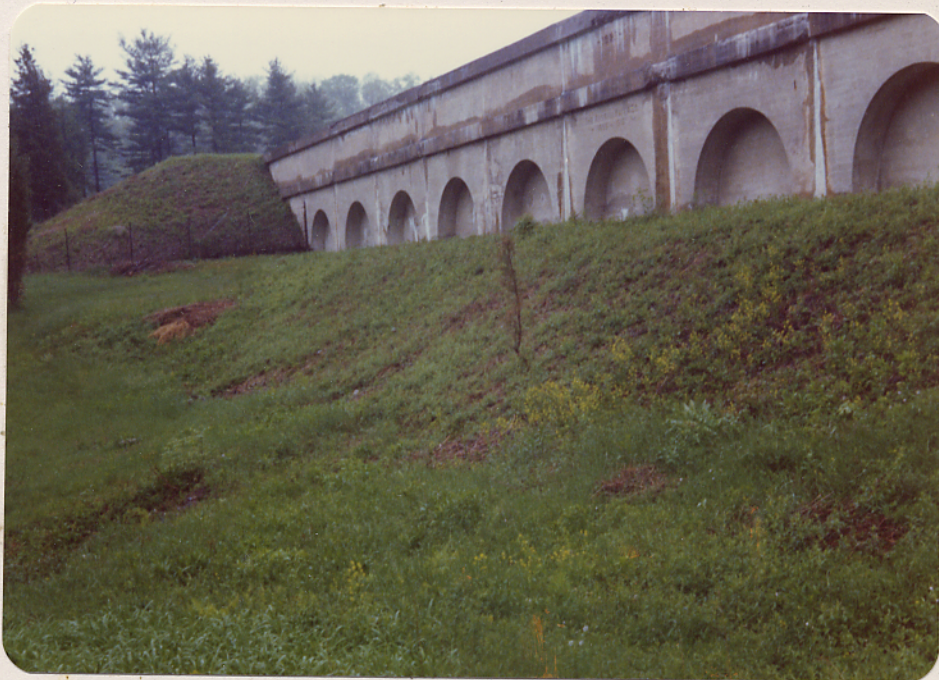
Downstream Berm - The downstream berm is generally in good condition with no sloughing or wet spots noted. There are a few holes made by burrowing animals on the slope and against the concrete wall at the edges of the concrete buttresses. A leak in the concrete wall at the

PHOTO NO.2 - General view of slope of downstream berm of dam section consisting of concrete/rubble wall with earth berms.
